# Access Compliance Report Public Rights-of-Way (Curb Ramps)

| Main Street: RIBERA_RD | | Cross Street: ASCENSO_AVE | | Location: | SW |
| ADA ID: RPRK211117170252 | Ramp Type: Type 1 - Perpendicular | Initial Pass/Fail: Pass | Overall Compliance: No | Severity Score: | 5 |

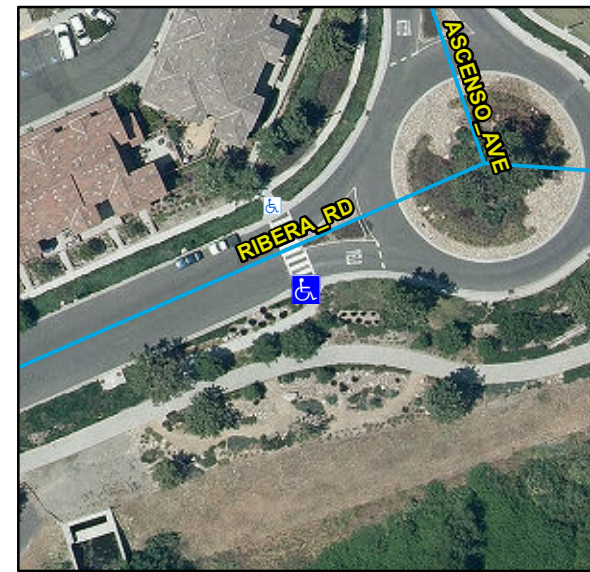
R304.5.4, R304.5.3, STD 1115

| Compliance | Description | Data | Compliance | Description | Data |
|---|---|---|---|---|---|
| No | Gutter Run Slope (%) | 6.5 | | Road Cross Slope (%) | N/A |
| No | Gutter Cross Slope (%) | 2.3 | | | |

Possible Solutions:

Remove & Replace Gutter.

Total Cost: \$ 252
