# Access Compliance Report Public Rights-of-Way (Curb Ramps)

Main Street: WALDEN\_ST Cross Street: LAURELHURST\_ST Location: NW

ADA ID: RPRK211118115115 Ramp Type: Type 4 - Parallel Initial Pass/Fail: Pass Overall Compliance: No Severity Score: 25

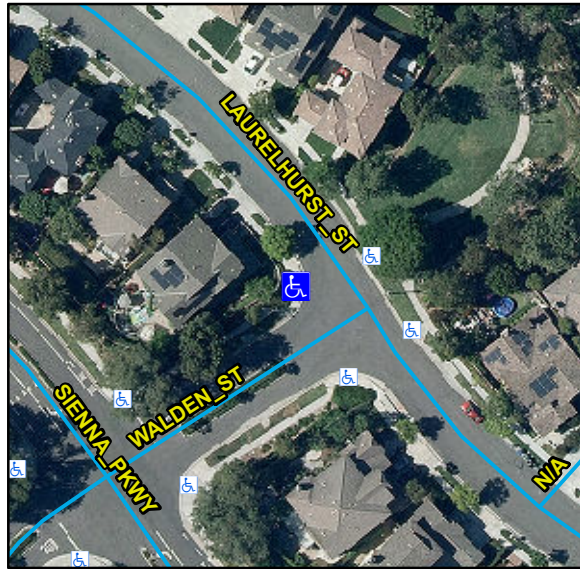
| Compliance | Description | Data | Compliance | Description | Data |
|---|---|---|---|---|---|
| N/A | Landing Present | No | No | DWS Provided | No |
| No | Landing Width (in) | N/A | N/A | DWS Length (in) | N/A |
| No | Landing Run Slope (%) | N/A | N/A | DWS Full Width | N/A |
| No | Landing Cross Slope (%) | N/A | | DWS Offset Type | N/A |
| No | Gutter Run Slope (%) | 9 | | Road Cross Slope (%) | 2.3 |

Remove & Replace Curb Ramp With Two New Directional Ramps or Equivalent. Remove & Replace Gutter.
