# Access Compliance Report Public Rights-of-Way (Curb Ramps)

| Main Street: LAURELHURST_ST | | Cross Street: WALDEN_ST | | Location: | SW |
| ADA ID: RPRK211118115327 | Ramp Type: Type 4 - Parallel | Initial Pass/Fail: Fail | Overall Compliance: No | Severity Score: | 32 |

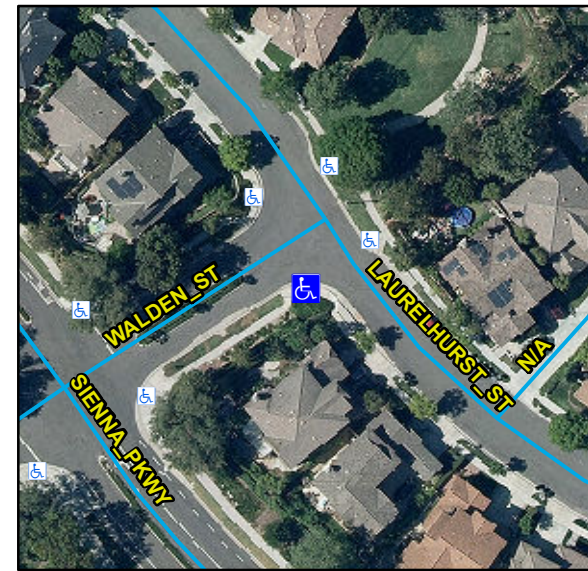
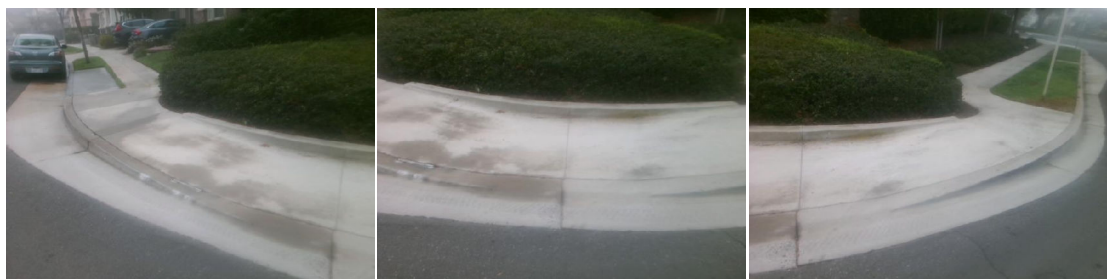
| Compliance | Description | Data | Compliance | Description | Data |
|---|---|---|---|---|---|
| No | Ramp Run Slope LT (%) | 12.2 | Yes | Ramp Run Slope RT (%) | 0.8 |
| No | Ramp Cross Slope LT (%) | 2.7 | Yes | Ramp Cross Slope RT (%) | 0.9 |

**Remove & Replace Curb Ramp With Two New Directional Ramps or Equivalent.**

**R304.3.2, R304.5.3, STD 1115**

Total Cost: \$ 4000
