# Access Compliance Report Public Rights-of-Way (Curb Ramps)

| Main Street: LAURELHURST_ST | | Cross Street: LAURELHURST_ST | | Location: | SE |
| ADA ID: RPRK211118115534 | Ramp Type:Type 1 - Perpendicular | Initial Pass/Fail: Fail | Overall Compliance: No | Severity Score: | 15 |

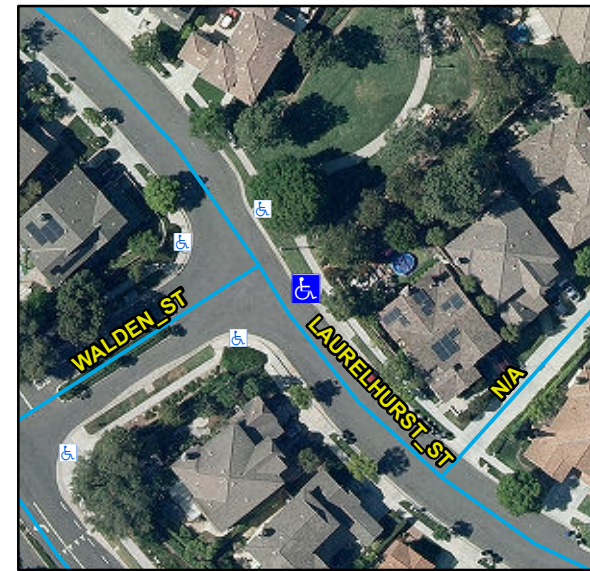
**R304.2.2, R204.3, STD 1115**

| Compliance | Description | Data | Compliance | Description | Data |
|---|---|---|---|---|---|
| No | Ramp Run Slope (%) | 8.6 | N/A | Flare Slope LT (%) | N/A |

**Remove & Replace Entire Ramp.**
