## **Access Compliance Report Public Rights-of-Way** (Curb Ramps)

Main Street: O NEILL DR **Cross Street: N/A** Location: SE

ADA ID: RPRK211118115939 Ramp Type:Type 1 - Perpendicular Diagonal Initial Pass/Fail: Pass

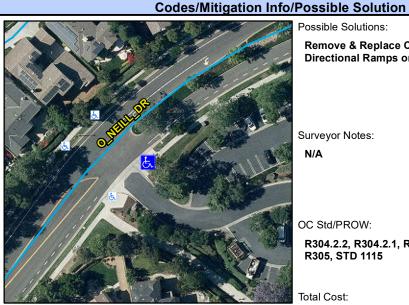
**Overall Compliance: No**

Field Measurements/Component Compliance								
Com	pliance Description	Data	Com	pliance	Description	Data		
N/A	Ramp Length (in)	136	N/A	Flare Typ	e LT			
Yes	Ramp Width (in)	48				Sloped		
Yes	Ramp Run Slope (%)	4.8	Yes	Flare Slope LT (%)		4		
Yes	Ramp Cross Slope (%)	1.4	N/A	Flare Traversable LT		Yes		
N/A	Landing Present	Yes	N/A	Flare Type RT				
N/A	Landing Length (in)	47		Slope		Sloped		
Yes	Landing Width (in)	48	Yes	Flare Slope RT (%)		5.9		
No	Landing Run Slope (%)	2.9	N/A	Flare Traversable RT		Yes		
Yes	Landing Cross Slope (%)	0.1	No	DWS Provided		No		
N/A	Landing Movement Obstructed?	No	N/A	DWS Cor	ntrast	N/A		
	Landing Movement Type	N/A	N/A	DWS Len	ngth (in)	N/A		
N/A	Landing Shared	No	N/A	DWS Full	Width	N/A		
N/A	Clear Space	Yes	N/A	DWS Offs	set Left (in)	N/A		
N/A	Clear Space To Crosswalk (in)	48	N/A	DWS Offs	set Right (in)	N/A		
N/A	Marked Crosswalk 1	No	N/A	Marked C	Crosswalk 2	No		
	Crossing 1 Direction	N		Crossing	2 Direction	W

Marked Crosswalk 1 Width (in)	N/A		Marked C	Crosswalk 2 Width (in)	N/A		
N/A	Ramp Inside Crosswalk 1	N/A	Yes	Ramp Ins	side Crosswalk 2	N/A		
	Crossing 1 Slope (%)	3		Crossing	2 Slope (%)	0.6		
	Crossing 1 Cross Slope (%)	1.4		Crossing	2 Cross Slope (%)	8.0		
Yes	Gutter Ponding	No	No	Curb Slop	ре	9		
Yes	Gutter Lip Height (in)	0		Road Ru	n Slope (%)	0.6		
Yes	Gutter Run Slope (%)	3.7		Road Cro	oss Slope (%)	0.7		
Yes	Gutter Cross Slope (%)	0.7						
Yes	Yes Overall Surface Condition: Acceptable Yes		Perp Joir	nt Present	Yes			
	Cross Gutter Present?	Yes		Spandrel	Present?	Yes		
	Replace Cross Gutter?	No		Replace	Spandrel?	No

Possible Solutions: Remove & Replace Curb Ramp With Two New Directional Ramps or Equivalent.
