# Access Compliance Report Public Rights-of-Way (Curb Ramps)

Main Street: N/A Cross Street: O\_NEILL\_DR Location: SW

ADA ID: RPRK211118120217 Ramp Type: Type 1 - Perpendicular Diagonal Initial Pass/Fail: Pass Overall Compliance: No Severity Score: 19

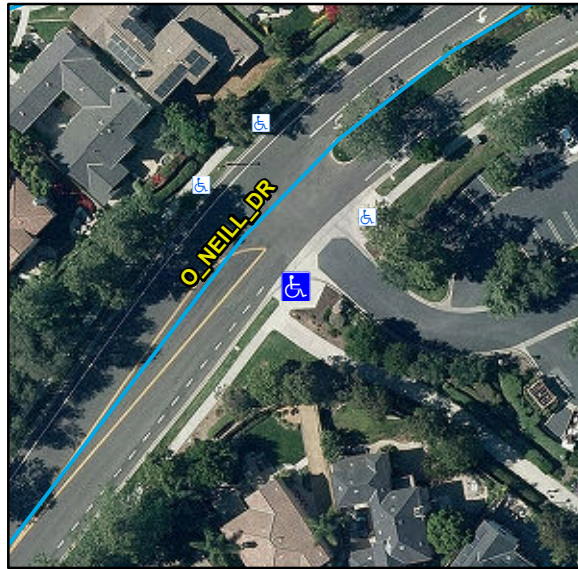
| Compliance | Description | Data | Compliance | Description | Data |
|---|---|---|---|---|---|
| Yes | Landing Cross Slope (%) | 4.5 | No | DWS Provided | No |
| No | Gutter Run Slope (%) | 6 | | Road Cross Slope (%) | 5.3 |

**Remove & Replace Curb Ramp With Two New Directional Ramps or Equivalent. Remove & Replace Gutter.**
