# Access Compliance Report Public Rights-of-Way (Curb Ramps)

Main Street: O\_NEILL\_DR Cross Street: N/A Location: NE

ADA ID: RPRK211118120811 Ramp Type: Type 1 - Perpendicular Diagonal Initial Pass/Fail: Pass Overall Compliance: No Severity Score: 20

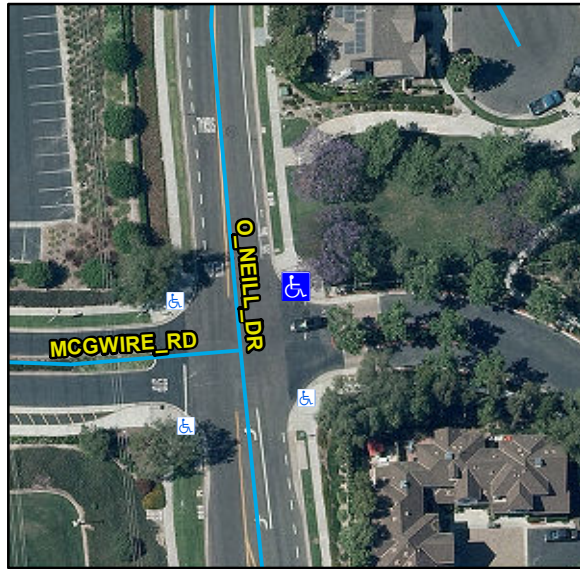
| Compliance | Description | Data | Compliance | Description | Data |
|---|---|---|---|---|---|
| No | Landing Run Slope (%) | 3 | N/A | Flare Traversable RT | Yes |
| Yes | Landing Cross Slope (%) | 0.8 | No | DWS Provided | No |
| Yes | Gutter Ponding | No | No | Curb Slope | 16.2 |
| No | Gutter Run Slope (%) | 12.4 | | Road Cross Slope (%) | 1.9 |

Remove & Replace Curb Ramp With Two New Directional Ramps or Equivalent. Remove & Replace Gutter.
