# Access Compliance Report Public Rights-of-Way (Curb Ramps)

Main Street: N/A Cross Street: O\_NEILL\_DR Location: SE

ADA ID: RPRK211118121228 Ramp Type: Type 1 - Perpendicular Diagonal Initial Pass/Fail: Fail Overall Compliance: No Severity Score: 2

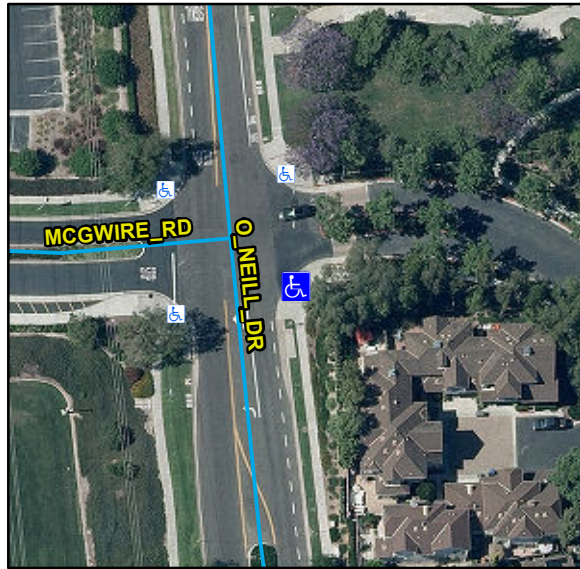
**R304.2.2, R204.3, R304.5.3, STD 1115**

| Compliance | Description | Data | Compliance | Description | Data |
|---|---|---|---|---|---|
| No | Ramp Cross Slope (%) | 4.8 | N/A | Flare Traversable LT | N/A |

**Remove & Replace Curb Ramp With Two New Directional Ramps or Equivalent.**
