# Access Compliance Report Public Rights-of-Way (Curb Ramps)

Main Street: DORRANCE\_DR Cross Street: O\_NEILL\_DR Location: S

ADA ID: RPRK211118121513 Ramp Type: Type 6 - Directional 1 Initial Pass/Fail: Fail Overall Compliance: No Severity Score: 30

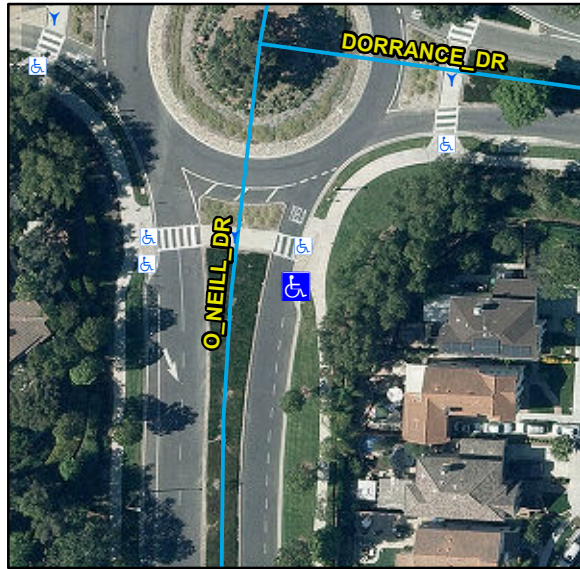
| Compliance | Description | Data | Compliance | Description | Data |
|---|---|---|---|---|---|
| No | Ramp Run Slope (%) | 16.8 | N/A | Flare Slope LT (%) | N/A |

Remove & Replace Entire Ramp.

R204.3, R304.2.2, STD 1115
