# Access Compliance Report Public Rights-of-Way (Curb Ramps)

Main Street: BRIOSO\_ST Cross Street: BRIOSO\_ST Location: NE

ADA ID: RPRK211118124141 Ramp Type: Type 4 - Parallel Initial Pass/Fail: Fail Overall Compliance: No Severity Score: 2

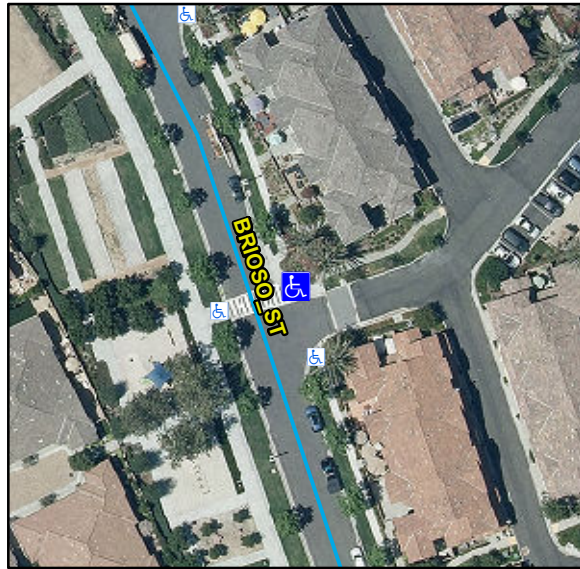
| Compliance | Description | Data | Compliance | Description | Data |
|---|---|---|---|---|---|
| Yes | Ramp Cross Slope LT (%) | 0.6 | No | Ramp Cross Slope RT (%) | 2.7 |

**Remove & Replace Curb Ramp With Two New Directional Ramps or Equivalent.**

**R304.5.3, STD 1115**
