# Access Compliance Report Public Rights-of-Way (Curb Ramps)

Main Street: BRIOSO\_ST Cross Street: BRIOSO\_ST Location: NW

ADA ID: RPRK211118124525 Ramp Type: Type 1 - Perpendicular Initial Pass/Fail: Pass Overall Compliance: No Severity Score: 5

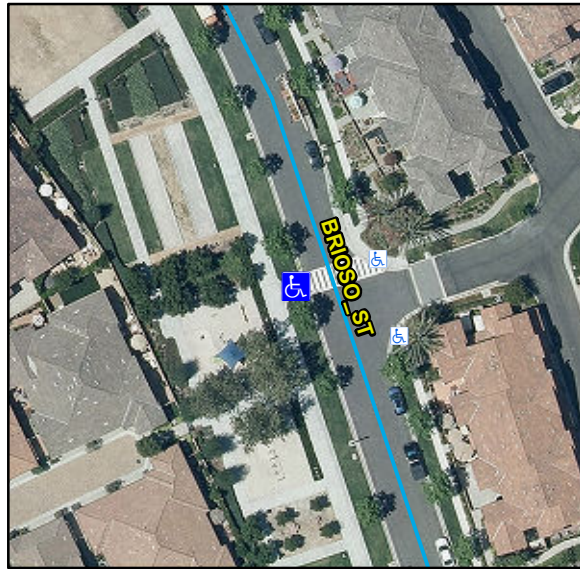
| Compliance | Description | Data | Compliance | Description | Data |
|---|---|---|---|---|---|
| Yes | Gutter Ponding | No | No | Curb Slope | 8.5 |
| No | Gutter Run Slope (%) | 8 | | Road Cross Slope (%) | N/A |

Remove & Replace Curb Slope. Remove & Replace Gutter.

R304.2.2, R304.5.4, STD 1115
