# Access Compliance Report Public Rights-of-Way (Curb Ramps)

Main Street: BRIOSO\_ST Cross Street: RIBERA\_RD Location: NE

ADA ID: RPRK211118125047 Ramp Type: Type 4 - Parallel Initial Pass/Fail: Fail Overall Compliance: No Severity Score: 2

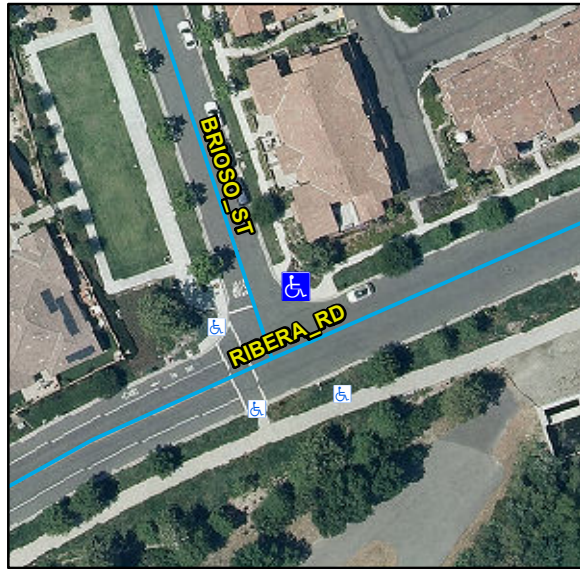
| Compliance | Description | Data | Compliance | Description | Data |
|---|---|---|---|---|---|
| No | Ramp Cross Slope LT (%) | 3.2 | Yes | Ramp Cross Slope RT (%) | 0.3 |

**Remove & Replace Curb Ramp With Two New Directional Ramps or Equivalent.**

**R304.5.3, STD 1115**
