# Access Compliance Report Public Rights-of-Way (Curb Ramps)

| Main Street: ORTEGA_HWY | | Cross Street: ORTEGA_HWY | | Location: | SE |
| ADA ID: RPRK211118130321 | Ramp Type: Type 1 - Perpendicular | Initial Pass/Fail: Fail | Overall Compliance: No | Severity Score: | 2 |

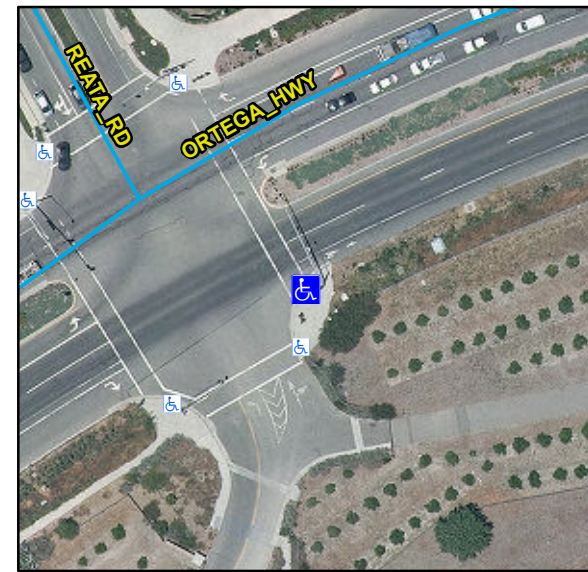
R304.2.2, R304.5.3, STD 1115

| Compliance | Description | Data | Compliance | Description | Data |
|---|---|---|---|---|---|
| No | Ramp Cross Slope (%) | 5 | N/A | Flare Traversable LT | N/A |
| N/A | Gutter Ponding | N/A | No | Curb Slope | 16.3 |

Remove & Replace Entire Ramp.

Total Cost: \$ 3080
