# Access Compliance Report Public Rights-of-Way (Curb Ramps)

Main Street: REATA\_RD Cross Street: ORTEGA\_HWY Location: NE

ADA ID: RPRK211118130709 Ramp Type: Type 1 - Perpendicular Diagonal Initial Pass/Fail: Fail Overall Compliance: No Severity Score: 16

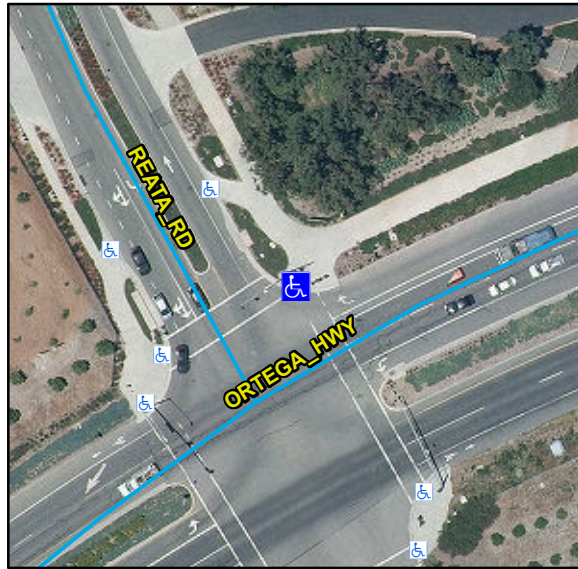
R304.2.2, R304.5.3, STD 1115

| Compliance | Description | Data | Compliance | Description | Data |
|---|---|---|---|---|---|
| No | Ramp Run Slope (%) | 9.4 | N/A | Flare Slope LT (%) | N/A |
| No | Ramp Cross Slope (%) | 4.1 | N/A | Flare Traversable LT | N/A |

Remove & Replace Curb Ramp With Two New Directional Ramps or Equivalent.
