# Access Compliance Report Public Rights-of-Way (Curb Ramps)

| Main Street: REATA_RD | | Cross Street: REATA_RD | | Location: | E |
| ADA ID: RPRK211118131223 | Ramp Type:Type 1 - Perpendicular | Initial Pass/Fail: Fail | Overall Compliance: No | Severity Score: | 2 |

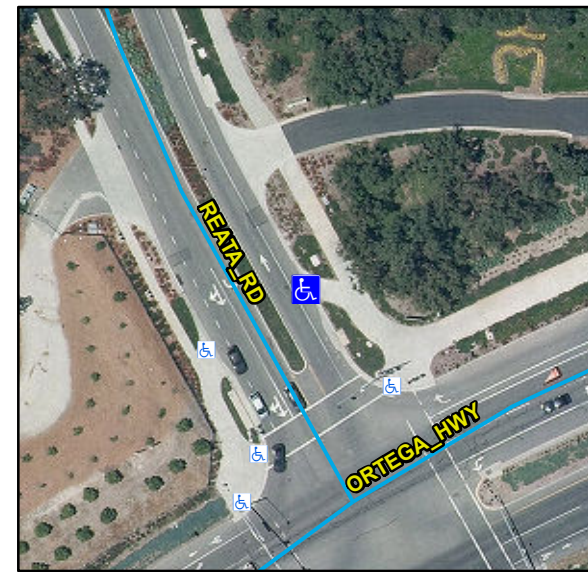
R304.2.2, R304.5.3, STD 1115

| Compliance | Description | Data | Compliance | Description | Data |
|---|---|---|---|---|---|
| No | Ramp Cross Slope (%) | 4.6 | N/A | Flare Traversable LT | N/A |

Remove & Replace Entire Ramp.
