# Access Compliance Report Public Rights-of-Way (Curb Ramps)

| Main Street: REATA_RD | | Cross Street: RIBERA_RD | | Location: | S |
| ADA ID: RPRK211118131918 | Ramp Type:Type 1 - Perpendicular | Initial Pass/Fail: Fail | Overall Compliance: No | Severity Score: | 16 |

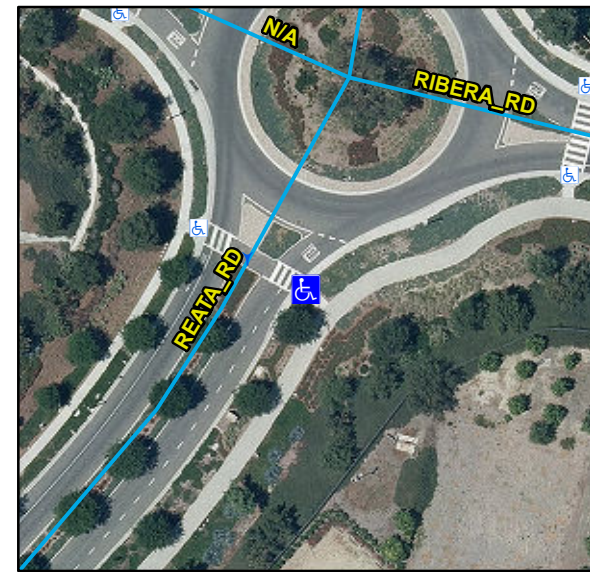
| Compliance | Description | Data | Compliance | Description | Data |
|---|---|---|---|---|---|
| No | Ramp Run Slope (%) | 9.5 | N/A | Flare Slope LT (%) | N/A |
| No | Ramp Cross Slope (%) | 3.7 | N/A | Flare Traversable LT | N/A |

Remove & Replace Entire Ramp.

R304.2.2, R304.5.3, STD 1115

\$ 3080
