# Access Compliance Report Public Rights-of-Way (Curb Ramps)

| Main Street: RIBERA_RD | | Cross Street: REATA_RD | | Location: | E |
| ADA ID: RPRK211118132036 | Ramp Type:Type 1 - Perpendicular | Initial Pass/Fail: Fail | Overall Compliance: No | Severity Score: | 16 |

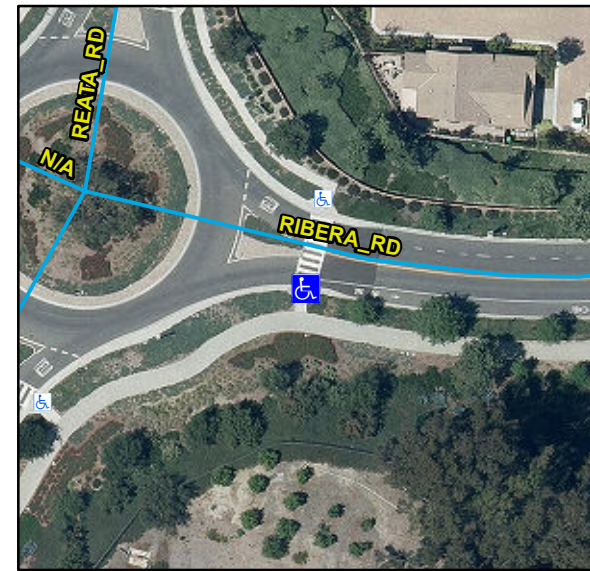
| Compliance | Description | Data | Compliance | Description | Data |
|---|---|---|---|---|---|
| No | Ramp Run Slope (%) | 8.9 | N/A | Flare Slope LT (%) | N/A |
| No | Ramp Cross Slope (%) | 4.5 | N/A | Flare Traversable LT | N/A |

Possible Solutions:

Remove & Replace Entire Ramp.

R304.2.2, R304.5.3, STD 1115
