# Access Compliance Report Public Rights-of-Way (Curb Ramps)

Main Street: RIBERA\_RD Cross Street: REATA\_RD Location: E

ADA ID: RPRK211118132209 Ramp Type: Type 1 - Perpendicular Initial Pass/Fail: Pass Overall Compliance: No Severity Score: 0

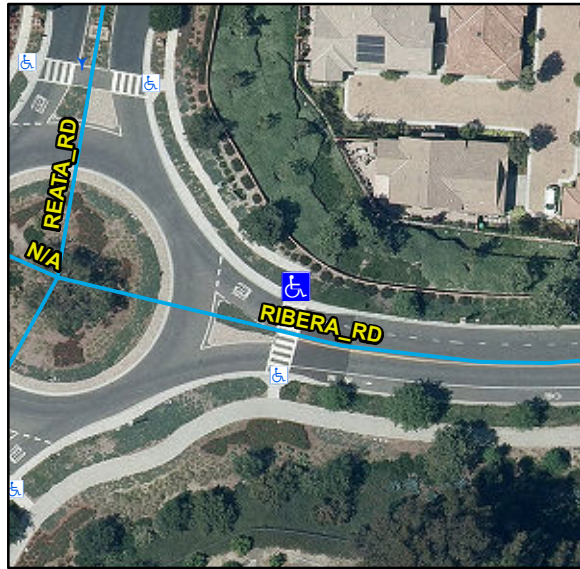
| Compliance | Description | Data | Compliance | Description | Data |
|---|---|---|---|---|---|
| No | Gutter Cross Slope (%) | 3.9 | | | |

Remove & Replace Gutter.

R304.5.3, STD 1115

\$ 252
