# Access Compliance Report Public Rights-of-Way (Curb Ramps)

| Main Street: REATA_RD | | Cross Street: RIBERA_RD | | Location: | N |
| ADA ID: RPRK211118132416 | Ramp Type:Type 1 - Perpendicular | Initial Pass/Fail: Fail | Overall Compliance: No | Severity Score: | 15 |

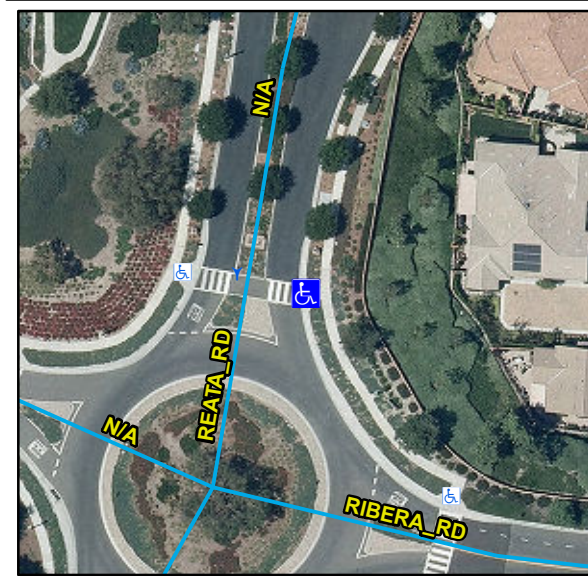
| Compliance | Description | Data | Compliance | Description | Data |
|---|---|---|---|---|---|
| No | Ramp Run Slope (%) | 11.1 | N/A | Flare Slope LT (%) | N/A |
| N/A | Gutter Ponding | N/A | No | Curb Slope | 14 |

Possible Solutions:

Remove & Replace Entire Ramp.

R304.2.2, STD 1115
