# Access Compliance Report Public Rights-of-Way (Curb Ramps)

| Main Street: REATA_RD | | Cross Street: N/A | | Location: | N |
| ADA ID: RPRK211118132744 | Ramp Type:Type 1 - Perpendicular | Initial Pass/Fail: Fail | Overall Compliance: No | Severity Score: | 16 |

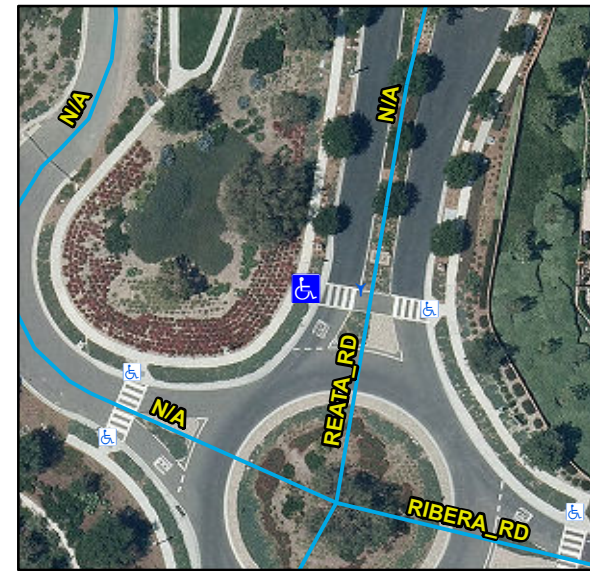
| Compliance | Description | Data | Compliance | Description | Data |
|---|---|---|---|---|---|
| No | Ramp Run Slope (%) | 9.3 | N/A | Flare Slope LT (%) | N/A |
| No | Ramp Cross Slope (%) | 2.6 | N/A | Flare Traversable LT | N/A |

Remove & Replace Entire Ramp.

R304.2.2, R304.5.3, STD 1115
