# Access Compliance Report Public Rights-of-Way (Curb Ramps)

| Main Street: N/A | | Cross Street: REATA_RD | | Location: | W |
| ADA ID: RPRK211118132839 | Ramp Type:Type 1 - Perpendicular | Initial Pass/Fail: Fail | Overall Compliance: No | Severity Score: | 16 |

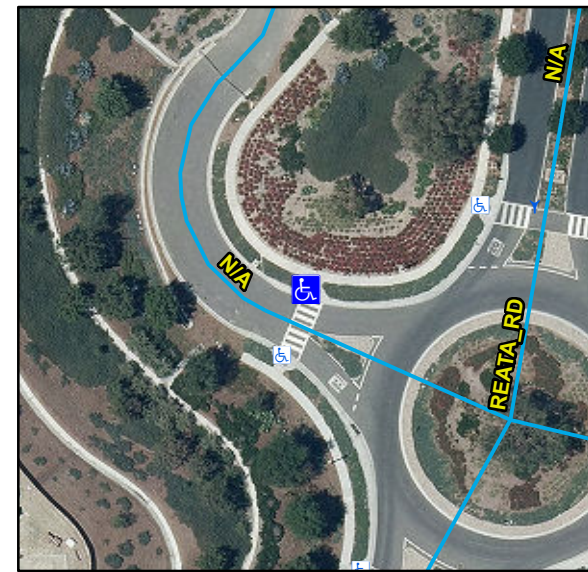
| Compliance | Description | Data | Compliance | Description | Data |
|---|---|---|---|---|---|
| No | Ramp Run Slope (%) | 8.8 | N/A | Flare Slope LT (%) | N/A |
| No | Ramp Cross Slope (%) | 2.4 | N/A | Flare Traversable LT | N/A |

Possible Solutions:

Remove & Replace Entire Ramp.

R304.2.2, R304.5.3, STD 1115
