# Access Compliance Report Public Rights-of-Way (Curb Ramps)

Main Street: N/A Cross Street: REATA\_RD Location: W

ADA ID: RPRK211118133012 Ramp Type: Type 1 - Perpendicular Initial Pass/Fail: Pass Overall Compliance: No Severity Score: 0

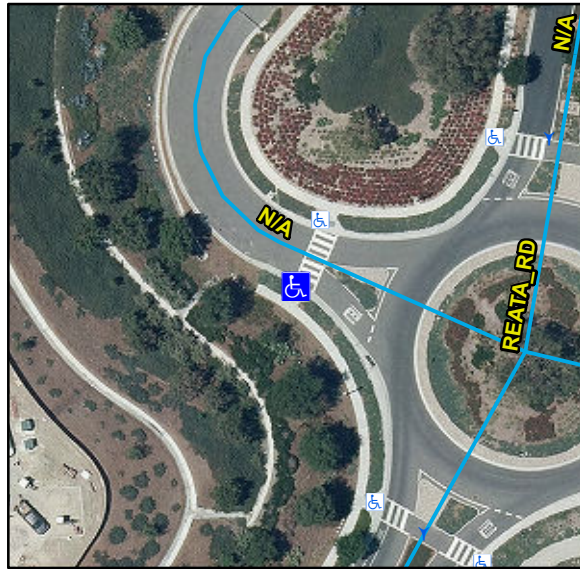
R304.2.2, STD 1115

| Compliance | Description | Data | Compliance | Description | Data |
|---|---|---|---|---|---|
| Yes | Gutter Ponding | No | No | Curb Slope | 5.9 |

Remove & Replace Curb Slope.
