# Access Compliance Report Public Rights-of-Way (Curb Ramps)

| Main Street: REATA_RD | | Cross Street: N/A | | Location: | S |
| ADA ID: RPRK211118133203 | Ramp Type:Type 1 - Perpendicular | Initial Pass/Fail: Fail | Overall Compliance: No | Severity Score: | 15 |

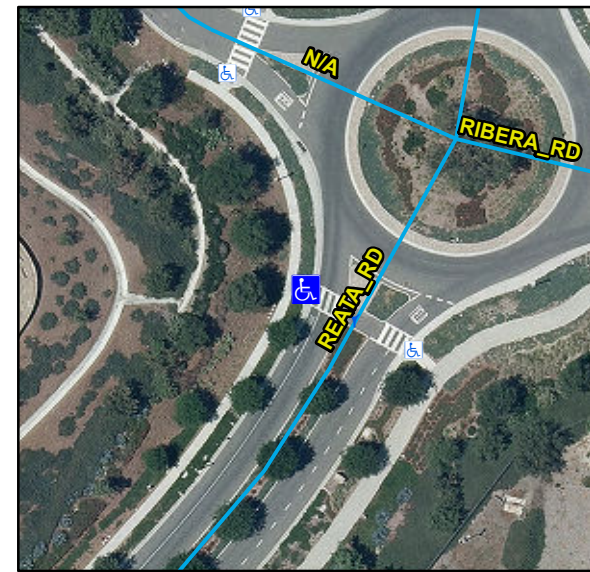
| Compliance | Description | Data | Compliance | Description | Data |
|---|---|---|---|---|---|
| No | Ramp Run Slope (%) | 8.6 | N/A | Flare Slope LT (%) | N/A |

Remove & Replace Entire Ramp.

R304.2.2, STD 1115

\$ 3080
