# Access Compliance Report Public Rights-of-Way (Curb Ramps)

Main Street: REATA\_RD Cross Street: N/A Location: NE

ADA ID: RPRK211118133741 Ramp Type: Type 1 - Perpendicular Initial Pass/Fail: Fail Overall Compliance: No Severity Score: 2

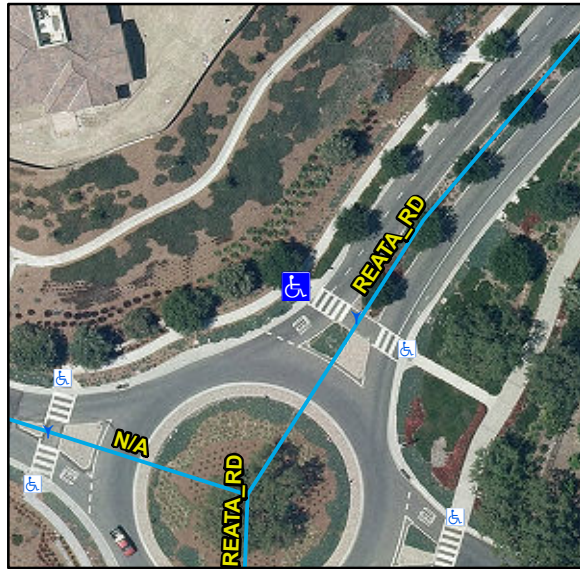
| Compliance | Description | Data | Compliance | Description | Data |
|---|---|---|---|---|---|
| No | Ramp Cross Slope (%) | 2.7 | N/A | Flare Traversable LT | N/A |
| N/A | Gutter Ponding | N/A | No | Curb Slope | 5.4 |

Remove & Replace Entire Ramp.

R304.2.2, R304.5.3, STD 1115
