# Access Compliance Report Public Rights-of-Way (Curb Ramps)

Main Street: REATA\_RD Cross Street: N/A Location: NE

ADA ID: RPRK211118134049 Ramp Type: Type 1 - Perpendicular Initial Pass/Fail: Pass Overall Compliance: No Severity Score: 0

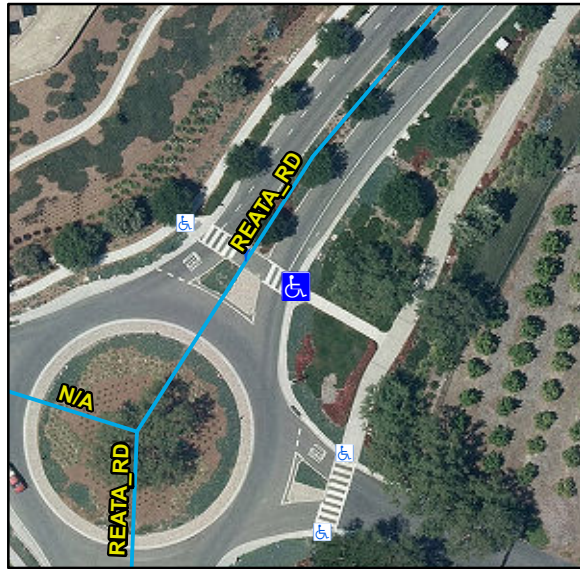
| Compliance | Description | Data | Compliance | Description | Data |
|---|---|---|---|---|---|
| Yes | Gutter Ponding | No | No | Curb Slope | 8.8 |

Remove & Replace Curb Slope.

R304.2.2, STD 1115

Total Cost: \$ 252
