# Access Compliance Report Public Rights-of-Way (Curb Ramps)

Main Street: N/A Cross Street: REATA\_RD Location: SE

ADA ID: RPRK211118134247 Ramp Type: Type 1 - Perpendicular Initial Pass/Fail: Fail Overall Compliance: No Severity Score: 2

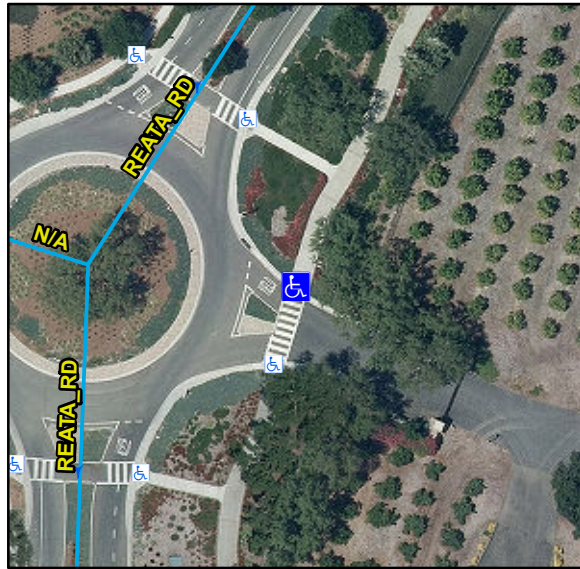
| Compliance | Description | Data | Compliance | Description | Data |
|---|---|---|---|---|---|
| No | Ramp Cross Slope (%) | 3.8 | N/A | Flare Traversable LT | N/A |

Remove & Replace Entire Ramp.

R204.3, R304.5.3, STD 1115
