# Access Compliance Report Public Rights-of-Way (Curb Ramps)

Main Street: N/A Cross Street: REATA\_RD Location: SE

ADA ID: RPRK211118134441 Ramp Type: Type 1 - Perpendicular Initial Pass/Fail: Fail Overall Compliance: No Severity Score: 0

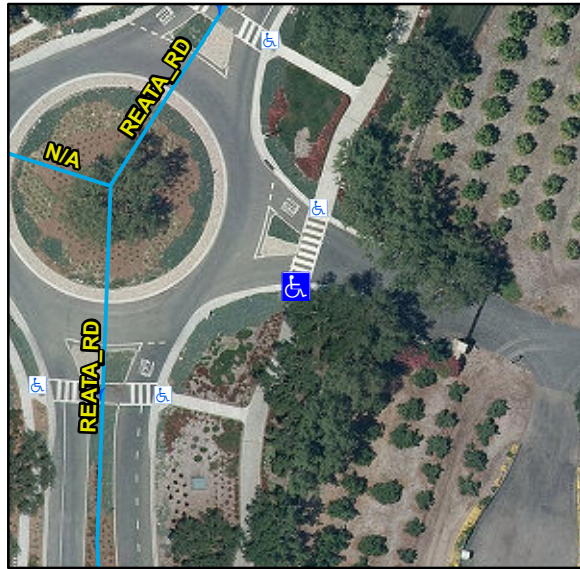
## Field Measurements/Component Compliance

Possible Solutions:

Remove & Replace Entire Ramp.

R304.2.2, R204.3, STD 1115
