# Access Compliance Report Public Rights-of-Way (Curb Ramps)

Main Street: N/A Cross Street: REATA\_RD Location: NW

ADA ID: RPRK211118135123 Ramp Type: Type 1 - Perpendicular Initial Pass/Fail: Fail Overall Compliance: No Severity Score: 16

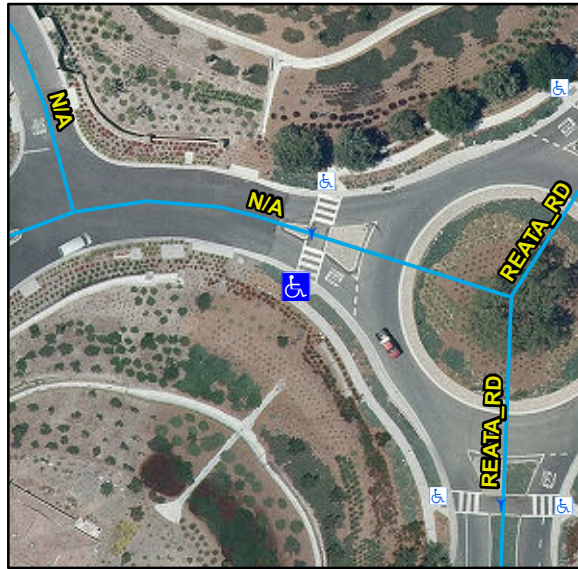
| Compliance | Description | Data | Compliance | Description | Data |
|---|---|---|---|---|---|
| No | Ramp Run Slope (%) | 8.4 | N/A | Flare Slope LT (%) | N/A |
| No | Ramp Cross Slope (%) | 2.1 | N/A | Flare Traversable LT | N/A |

Remove & Replace Entire Ramp.

R304.2.2, R304.5.3, STD 1115

\$ 3080
