# Access Compliance Report Public Rights-of-Way (Curb Ramps)

| Main Street: N/A | | Cross Street: REATA_RD | | Location: | NW |
| ADA ID: RPRK211118135428 | Ramp Type: Type 1 - Perpendicular | Initial Pass/Fail: Fail | Overall Compliance: No | Severity Score: | 16 |

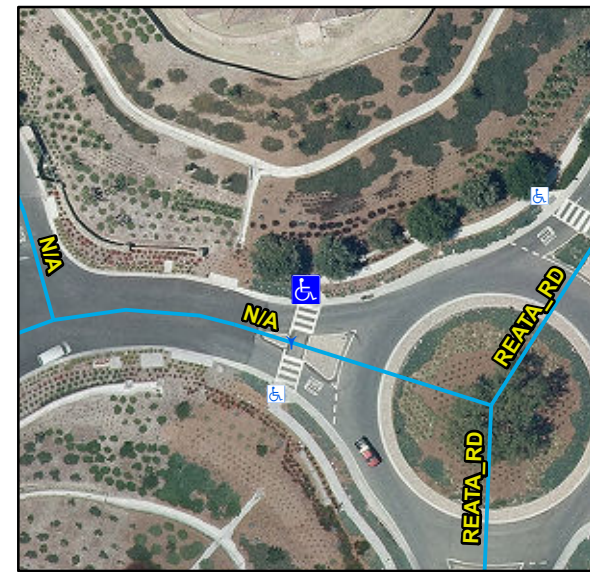
| Compliance | Description | Data | Compliance | Description | Data |
|---|---|---|---|---|---|
| No | Ramp Run Slope (%) | 10.1 | N/A | Flare Slope LT (%) | N/A |

Possible Solutions:

Remove & Replace Entire Ramp.

R304.2.2, STD 1115

\$ 3080
