# Access Compliance Report Public Rights-of-Way (Curb Ramps)

| Main Street: REATA_RD | | Cross Street: REATA_RD | | Location: | W |
| ADA ID: RPRK211118135946 | Ramp Type:Type 1 - Perpendicular | Initial Pass/Fail: Fail | Overall Compliance: No | Severity Score: | 16 |

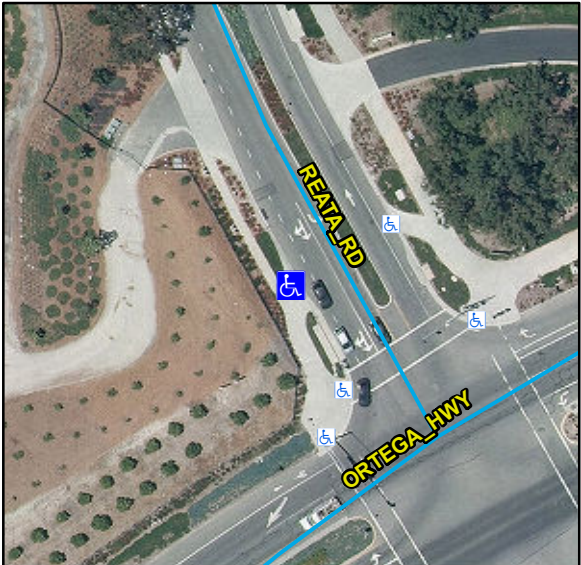
| | R304.2.2, R304.5.3, STD 1115 | | | | |
| | No | Ramp Run Slope (%) | 10.6 | N/A | Flare Slope LT (%) |
| | No | Ramp Cross Slope (%) | 4.5 | N/A | Flare Traversable LT |

| | Remove & Replace Entire Ramp. | | | | |
