# Access Compliance Report Public Rights-of-Way (Curb Ramps)

| Main Street: REATA_RD | | Cross Street: ORTEGA_HWY | | Location: | NW |
| ADA ID: RPRK211118140504 | Ramp Type: Type 1 - Perpendicular | Initial Pass/Fail: Pass | Overall Compliance: No | Severity Score: | 22 |

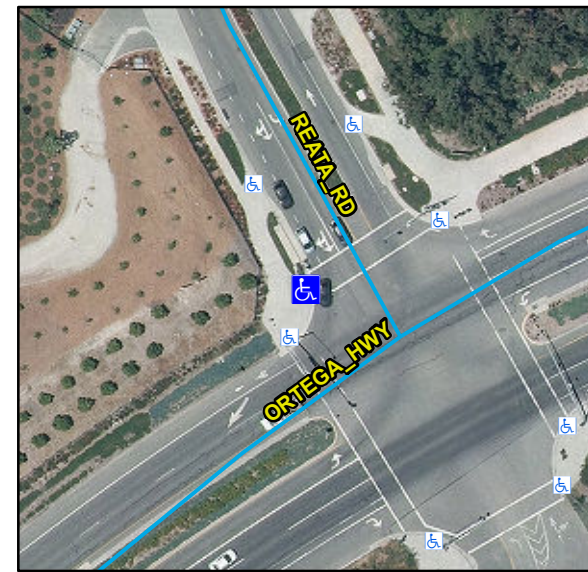
| Compliance | Description | Data | Compliance | Description | Data |
|---|---|---|---|---|---|
| Yes | Ramp Run Slope (%) | 6.9 | No | Flare Slope LT (%) | 10.9 |
| No | Ramp Cross Slope (%) | 5.6 | N/A | Flare Traversable LT | Yes |
| No | Landing Cross Slope (%) | 6.5 | Yes | DWS Provided | Yes |
| Yes | Gutter Ponding | No | No | Curb Slope | 6.8 |

Possible Solutions:

Remove & Replace Entire Ramp.

R304.2.2, R304.5.3, R304.2.3, STD 1115

Total Cost: \$ 3080

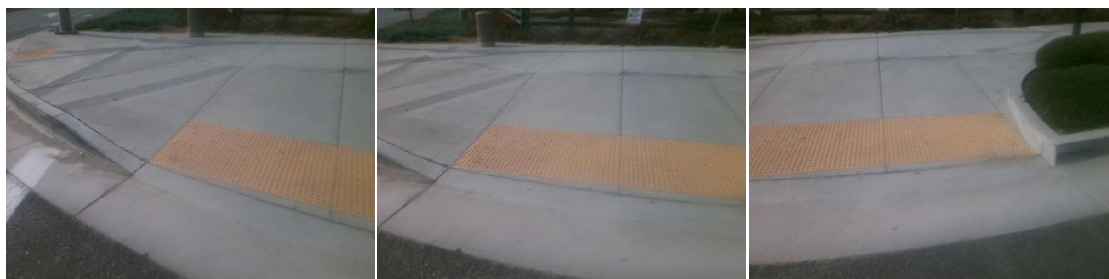
| Compliance | Description | Data | Compliance | Description | Data |
|---|---|---|---|---|---|
| N/A | Ramp Length (in) | 122 | N/A | Flare Type LT | |
| Yes | Ramp Width (in) | 117 | | | Sloped |
