# Access Compliance Report Public Rights-of-Way (Curb Ramps)

| Main Street: ORTEGA_HWY | | Cross Street: REATA_RD | | Location: | NW |
| ADA ID: RPRK211118140715 | Ramp Type: Type 1 - Perpendicular | Initial Pass/Fail: Fail | Overall Compliance: No | Severity Score: | 15 |

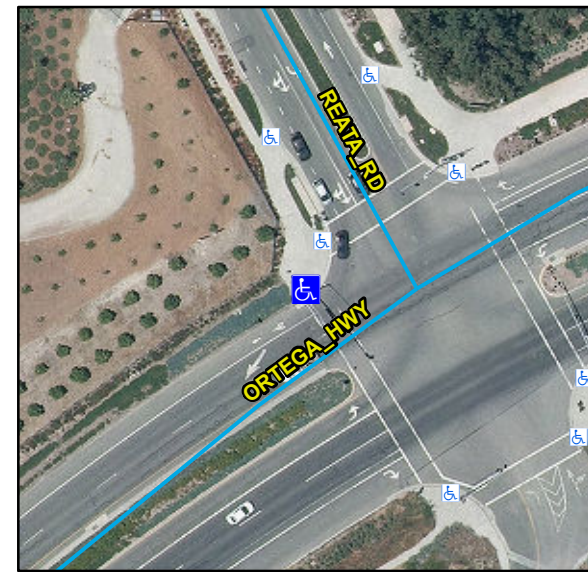
R304.2.2, R304.5.3, STD 1115

| Compliance | Description | Data | Compliance | Description | Data |
|---|---|---|---|---|---|
| No | Ramp Cross Slope (%) | 6.5 | N/A | Flare Traversable LT | N/A |

Remove & Replace Entire Ramp.
