# Access Compliance Report Public Rights-of-Way (Curb Ramps)

Main Street: ORTEGA\_HWY Cross Street: ORTEGA\_HWY Location: SW

ADA ID: RPRK211118141115 Ramp Type: Type 1 - Perpendicular Diagonal Initial Pass/Fail: Fail Overall Compliance: No Severity Score: 0

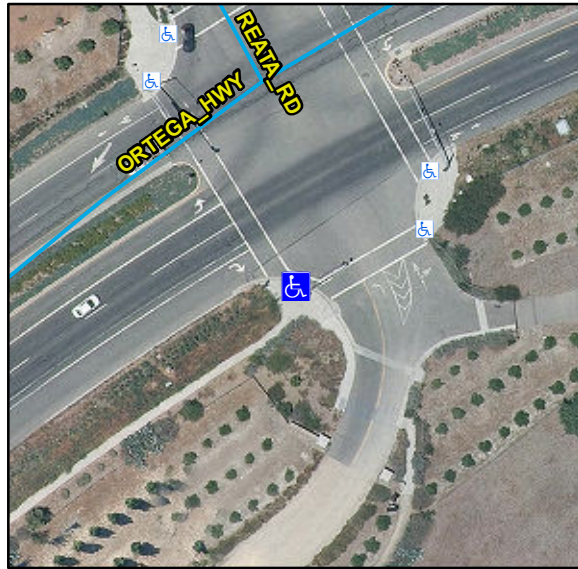
| Compliance | Description | Data | Compliance | Description | Data |
|---|---|---|---|---|---|
| N/A | Ramp Length (in) | 115 | N/A | Flare Type LT | |
| Yes | Ramp Width (in) | 48 | | | N/A |
| Yes | Ramp Run Slope (%) | 6.7 | N/A | Flare Slope LT (%) | N/A |
| Yes | Ramp Cross Slope (%) | 2.8 | N/A | Flare Traversable LT | N/A |
| N/A | Ramp Inside Crosswalk 1 | No | Yes | Ramp Inside Crosswalk 2 | No |
| N/A | Gutter Ponding | N/A | No | Curb Slope | 15.6 |

Remove & Replace Curb Ramp With Two New Directional Ramps or Equivalent. Restripe Crosswalk.

R304.2.2, STD 1115
