# Access Compliance Report Public Rights-of-Way (Curb Ramps)

Main Street: ANTONIO\_PKWY Cross Street: N/A Location: NE

ADA ID: RPRK211118142203 Ramp Type: Type 1 - Perpendicular Diagonal Initial Pass/Fail: Pass Overall Compliance: No Severity Score: 11

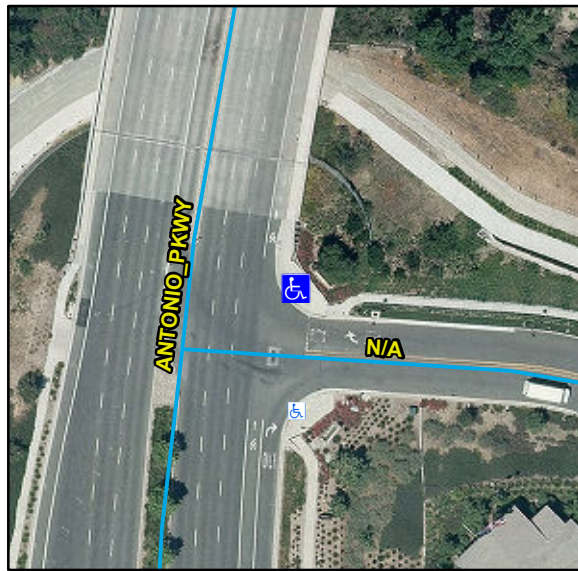
| Compliance | Description | Data | Compliance | Description | Data |
|---|---|---|---|---|---|
| Yes | Gutter Ponding | No | No | Curb Slope | 5.7 |
| No | Gutter Run Slope (%) | 11.7 | | Road Cross Slope (%) | 3.2 |

Remove & Replace Curb Ramp With Two New Directional Ramps or Equivalent. Remove & Replace Gutter.
