# Access Compliance Report Public Rights-of-Way (Curb Ramps)

Main Street: N/A Cross Street: ANTONIO\_PKWY Location: SE

ADA ID: RPRK211118142517 Ramp Type: Type 1 - Perpendicular Diagonal Initial Pass/Fail: Fail Overall Compliance: No Severity Score: 30

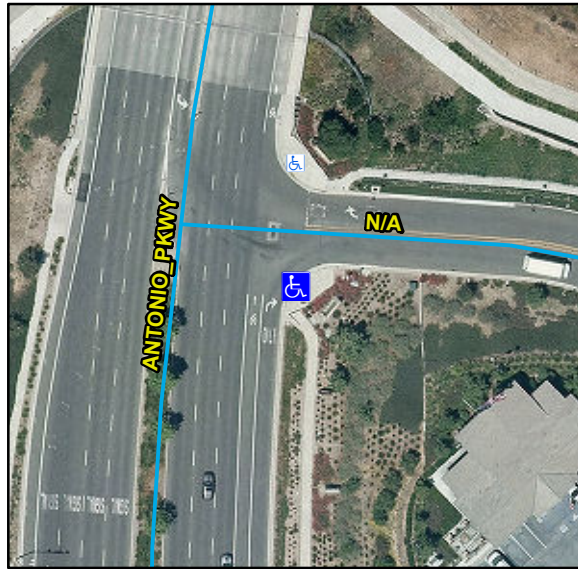
| Compliance | Description | Data | Compliance | Description | Data |
|---|---|---|---|---|---|
| No | Ramp Cross Slope (%) | 7.9 | N/A | Flare Traversable LT | N/A |
| N/A | Gutter Ponding | N/A | No | Curb Slope | 8.4 |

**Remove & Replace Curb Ramp With Two New Directional Ramps or Equivalent.**

**R304.2.2, R304.5.3, STD 1115**
