# Access Compliance Report Public Rights-of-Way (Curb Ramps)

Main Street: ANTONIO\_PKWY Cross Street: ORTEGA\_HWY Location: NW

ADA ID: RPRK211118143118 Ramp Type: Type 1 - Perpendicular Initial Pass/Fail: Pass Overall Compliance: No Severity Score: 5

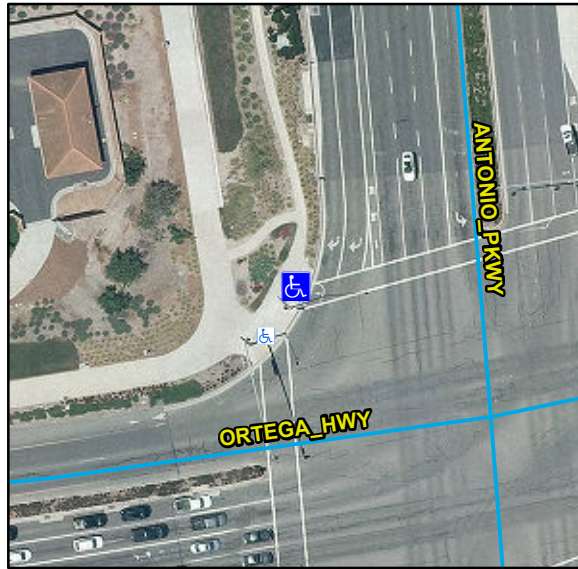
| Compliance | Description | Data | Compliance | Description | Data |
|---|---|---|---|---|---|
| No | Landing Cross Slope (%) | 4 | Yes | DWS Provided | Yes |
| Yes | Gutter Ponding | No | No | Curb Slope | 5.3 |
| No | Gutter Run Slope (%) | 5.2 | | Road Cross Slope (%) | N/A |
| No | Gutter Cross Slope (%) | 3 | | | |

Remove & Replace Entire Ramp. Remove & Replace Gutter.
