# Access Compliance Report Public Rights-of-Way (Curb Ramps)

Main Street: ORTEGA\_HWY Cross Street: ANTONIO\_PKWY Location: NW

ADA ID: RPRK211118143409 Ramp Type: Type 1 - Perpendicular Initial Pass/Fail: Fail Overall Compliance: No Severity Score: 16

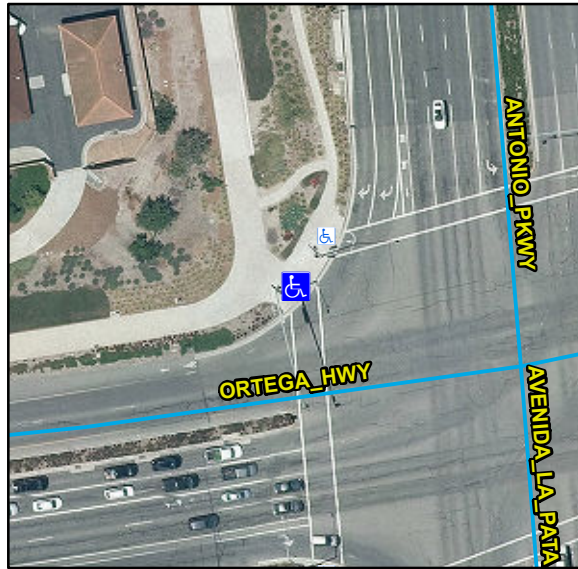
| Compliance | Description | Data | Compliance | Description | Data |
|---|---|---|---|---|---|
| No | Ramp Run Slope (%) | 9.6 | N/A | Flare Slope LT (%) | N/A |
| No | Ramp Cross Slope (%) | 4.8 | N/A | Flare Traversable LT | N/A |

Remove & Replace Entire Ramp.

R304.2.2, R304.5.3, STD 1115
