# Access Compliance Report Public Rights-of-Way (Curb Ramps)

| Main Street: ORTEGA_HWY | | Cross Street: ANTONIO_PKWY | | Location: | SW |
| ADA ID: RPRK211118143802 | Ramp Type: Type 1 - Perpendicular | Initial Pass/Fail: Fail | Overall Compliance: No | Severity Score: | 30 |

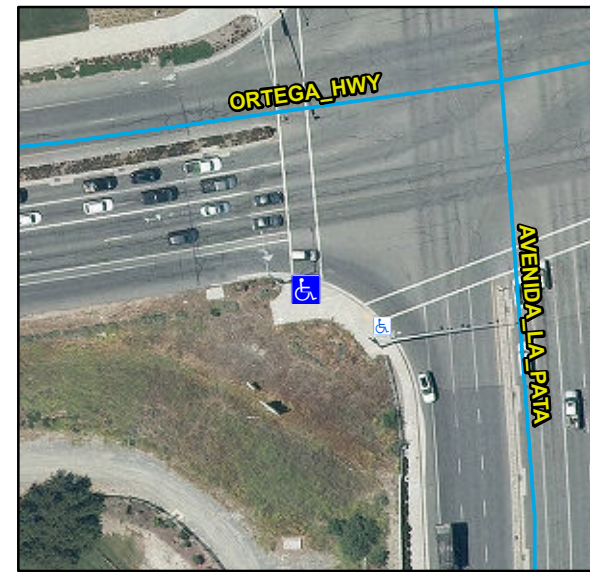
| Compliance | Description | Data | Compliance | Description | Data |
|---|---|---|---|---|---|
| No | Ramp Run Slope (%) | 8.9 | N/A | Flare Slope LT (%) | N/A |
| No | Ramp Cross Slope (%) | 5.6 | N/A | Flare Traversable LT | N/A |

Remove & Replace Entire Ramp.

R304.2.2, R304.5.3, STD 1115
