# Access Compliance Report Public Rights-of-Way (Curb Ramps)

| Main Street: AVENIDA_LA_PATA | | Cross Street: ORTEGA_HWY | | Location: | SW |
| ADA ID: RPRK211118144234 | Ramp Type:Type 1 - Perpendicular | Initial Pass/Fail: Fail | Overall Compliance: No | Severity Score: | 15 |

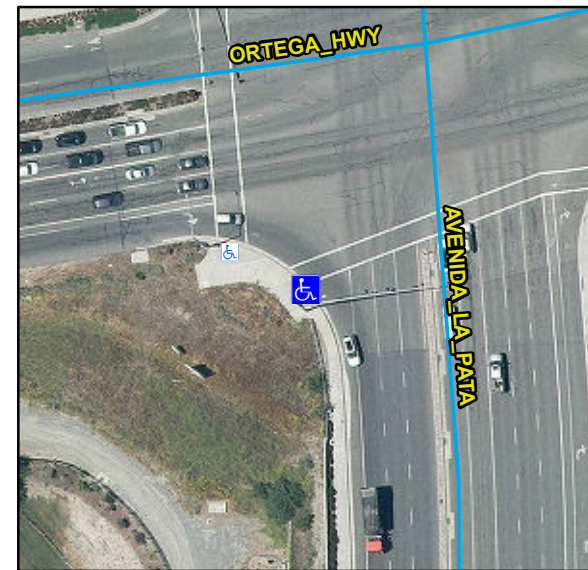
Surveyor Notes:

N/A

| Compliance | Description | Data | Compliance | Description | Data |
|---|---|---|---|---|---|
| No | Ramp Run Slope (%) | 9.7 | N/A | Flare Slope LT (%) | N/A |

Remove & Replace Entire Ramp.

OC Std/PROW:

R304.2.2, STD 1115

Total Cost: \$ 3080
