# Access Compliance Report Public Rights-of-Way (Curb Ramps)

Main Street: ENTONAR\_RD Cross Street: ESENCIA\_DR Location: N

ADA ID: RPRK211119114714 Ramp Type: Type 4 - Parallel Initial Pass/Fail: Fail Overall Compliance: No Severity Score: 16

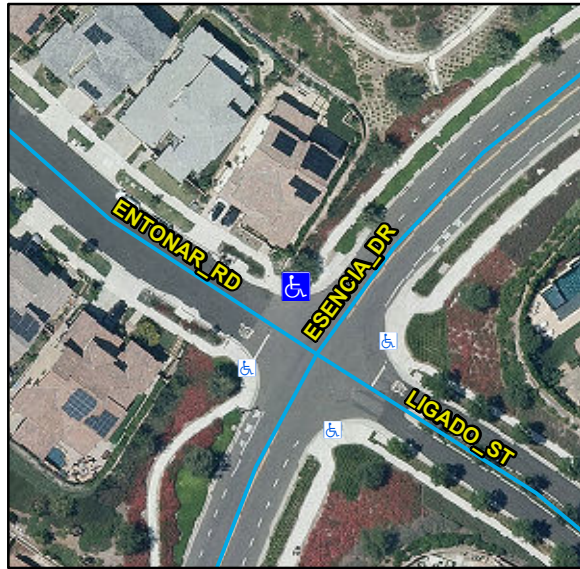
| Compliance | Description | Data | Compliance | Description | Data |
|---|---|---|---|---|---|
| Yes | Ramp Run Slope LT (%) | 0 | No | Ramp Run Slope RT (%) | 9.6 |
| No | Ramp Cross Slope LT (%) | 4.7 | Yes | Ramp Cross Slope RT (%) | 0 |

Remove & Replace Curb Ramp With Two New Directional Ramps or Equivalent.

R304.5.3, R304.3.2, STD 1115
