# Access Compliance Report Public Rights-of-Way (Curb Ramps)

| Main Street: ESENCIA_DR | | Cross Street: ENTONAR_RD | | Location: | W |
| ADA ID: RPRK211119115152 | Ramp Type: Type 4 - Parallel | Initial Pass/Fail: Fail | Overall Compliance: No | Severity Score: | 15 |

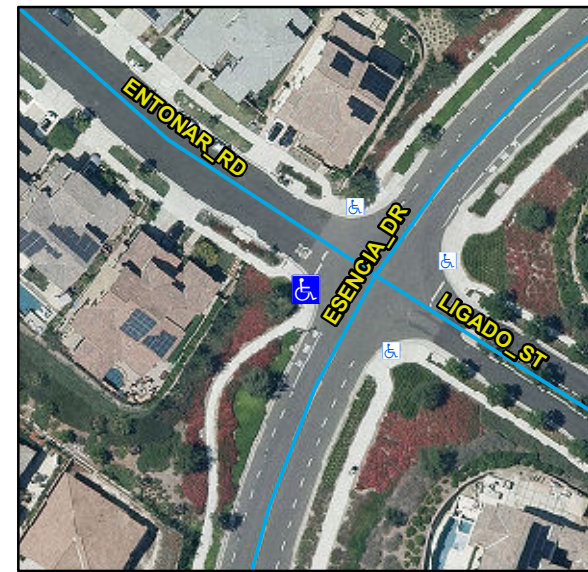
| Compliance | Description | Data | Compliance | Description | Data |
|---|---|---|---|---|---|
| Yes | Ramp Run Slope LT (%) | 5.6 | No | Ramp Run Slope RT (%) | 10.7 |

**Remove & Replace Curb Ramp With Two New Directional Ramps or Equivalent.**

**R304.3.2, STD 1115**
