# Access Compliance Report Public Rights-of-Way (Curb Ramps)

Main Street: AIROSO\_ST Cross Street: ENTONAR\_RD Location: SE

ADA ID: RPRK211119122442 Ramp Type: Type 1 - Perpendicular Diagonal Initial Pass/Fail: Pass Overall Compliance: No Severity Score: 0

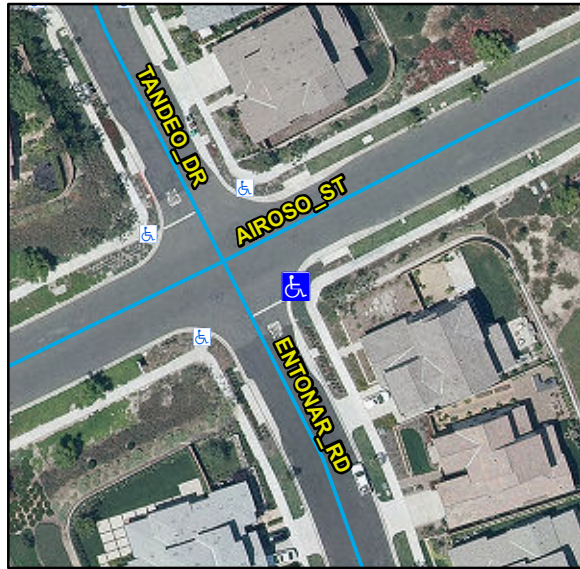
| Compliance | Description | Data | Compliance | Description | Data |
|---|---|---|---|---|---|
| No | Gutter Cross Slope (%) | 4.4 | | | |

Remove & Replace Gutter.

R304.5.3, STD 1115
