# Access Compliance Report Public Rights-of-Way (Curb Ramps)

Main Street: TANDEO\_DR Cross Street: AIROSO\_ST Location: NE

ADA ID: RPRK211119123233 Ramp Type: Type 1 - Perpendicular Diagonal Initial Pass/Fail: Fail Overall Compliance: No Severity Score: 2

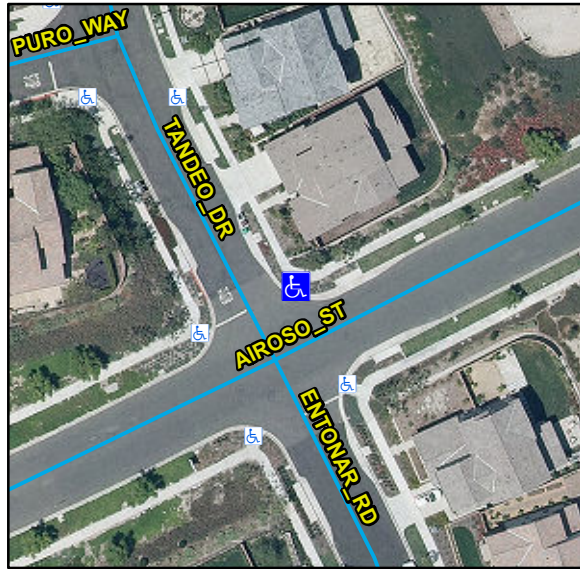
R304.2.2, R304.5.3, STD 1115

| Compliance | Description | Data | Compliance | Description | Data |
|---|---|---|---|---|---|
| No | Ramp Cross Slope (%) | 2.6 | N/A | Flare Traversable LT | N/A |

Remove & Replace Curb Ramp With Two New Directional Ramps or Equivalent.
