# Access Compliance Report Public Rights-of-Way (Curb Ramps)

Main Street: AIROSO\_ST Cross Street: TANDEO\_DR Location: NW

ADA ID: RPRK211119123706 Ramp Type: Type 1 - Perpendicular Diagonal Initial Pass/Fail: Fail Overall Compliance: No Severity Score: 2

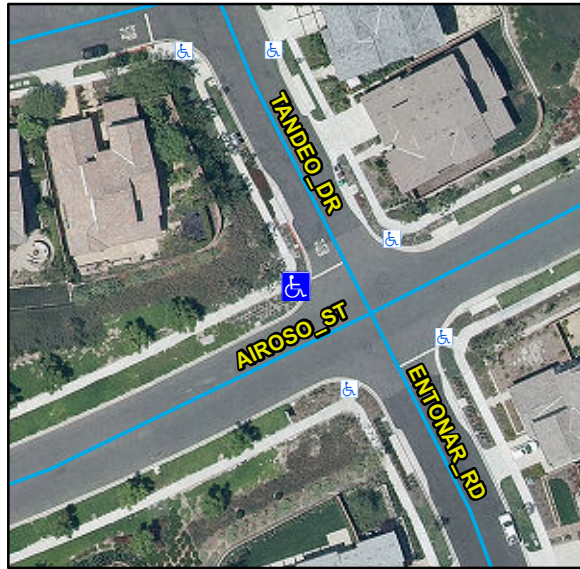
| Compliance | Description | Data | Compliance | Description | Data |
|---|---|---|---|---|---|
| No | Ramp Cross Slope (%) | 2.4 | N/A | Flare Traversable LT | N/A |

Remove & Replace Curb Ramp With Two New Directional Ramps or Equivalent.

R304.5.3, STD 1115
