# Access Compliance Report Public Rights-of-Way (Curb Ramps)

Main Street: PURO\_WAY Cross Street: TANDEO\_DR Location: SW

ADA ID: RPRK211119124118 Ramp Type: Type 4 - Parallel Initial Pass/Fail: Fail Overall Compliance: No Severity Score: 2

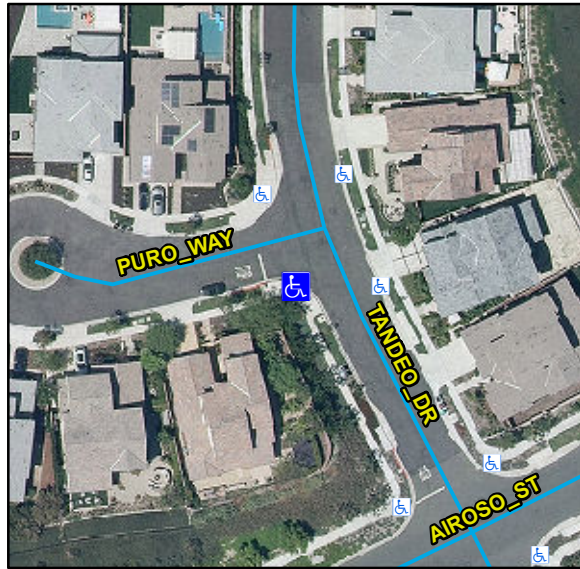
| Compliance | Description | Data | Compliance | Description | Data |
|---|---|---|---|---|---|
| Yes | Ramp Cross Slope LT (%) | 2 | No | Ramp Cross Slope RT (%) | 2.2 |

**Remove & Replace Curb Ramp With Two New Directional Ramps or Equivalent.**

**R304.5.3, STD 1115**

Total Cost: \$ 4000
