# Access Compliance Report Public Rights-of-Way (Curb Ramps)

| Main Street: PURO_WAY | | Cross Street: TANDEO_DR | | Location: | NW |
| ADA ID: RPRK211119124832 | Ramp Type: Type 4 - Parallel | Initial Pass/Fail: Fail | Overall Compliance: No | Severity Score: | 30 |

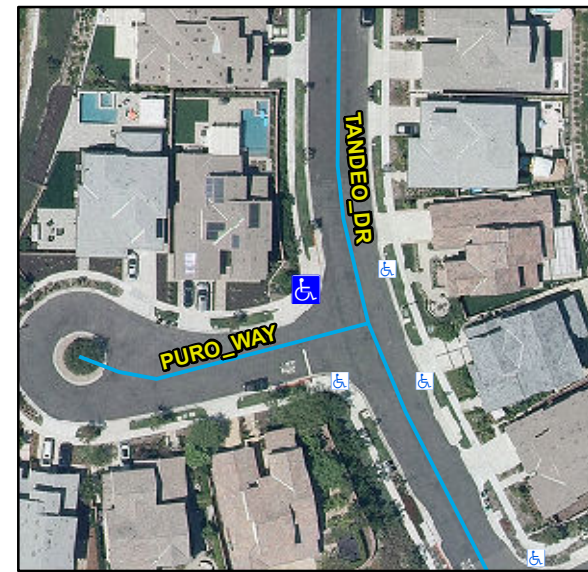
| Compliance | Description | Data | Compliance | Description | Data |
|---|---|---|---|---|---|
| Yes | Ramp Run Slope LT (%) | 0.1 | No | Ramp Run Slope RT (%) | 9.6 |
| No | Ramp Cross Slope LT (%) | 6.2 | No | Ramp Cross Slope RT (%) | 2.2 |

**Remove & Replace Curb Ramp With Two New Directional Ramps or Equivalent.**

**R204.3, R304.5.3, R304.3.2, STD 1115**

Total Cost: \$ 4000
