# Access Compliance Report Public Rights-of-Way (Curb Ramps)

| Main Street: ENTONAR_RD | | Cross Street: AIROSO_ST | | Location: | SW |
| ADA ID: RPRK211119125530 | Ramp Type:Type 1 - Perpendicular Diagonal Initial Pass/Fail: Fail | | Overall Compliance: No | Severity Score: | 2 |

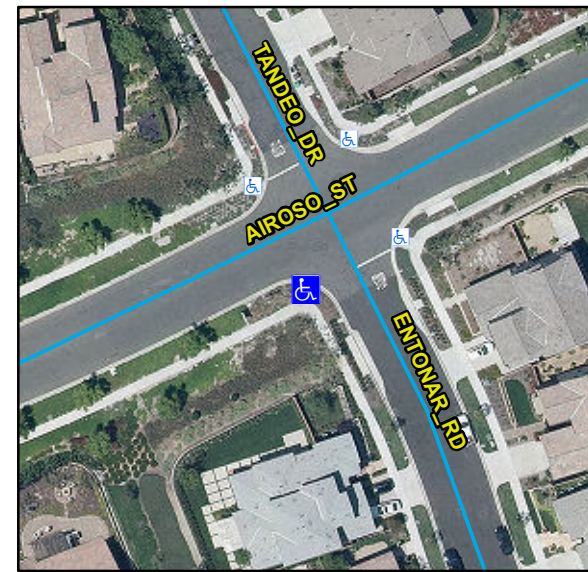
| Compliance | Description | Data | Compliance | Description | Data |
|---|---|---|---|---|---|
| No | Ramp Cross Slope (%) | 4.1 | N/A | Flare Traversable LT | N/A |

Remove & Replace Curb Ramp With Two New Directional Ramps or Equivalent.

R304.5.3, STD 1115
