# Access Compliance Report Public Rights-of-Way (Curb Ramps)

Main Street: RISILLA\_ST Cross Street: ESENCIA\_DR Location: NE

ADA ID: RPRK211119130605 Ramp Type: Type 4 - Parallel Initial Pass/Fail: Fail Overall Compliance: No Severity Score: 2

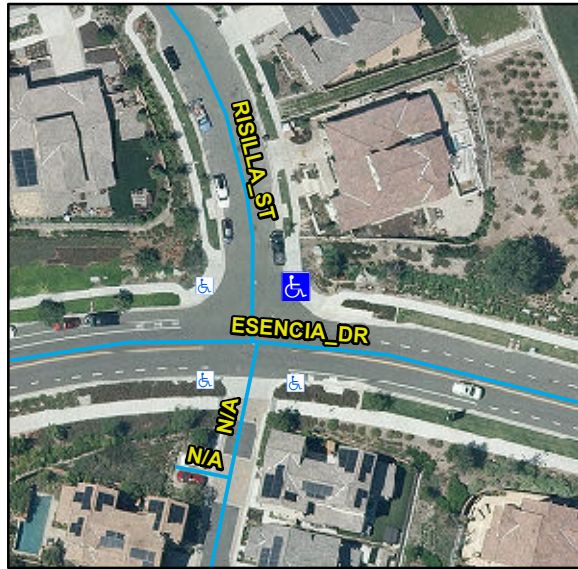
| Compliance | Description | Data | Compliance | Description | Data |
|---|---|---|---|---|---|
| No | Ramp Cross Slope LT (%) | 3.9 | Yes | Ramp Cross Slope RT (%) | 0.4 |
| N/A | Gutter Ponding | N/A | No | Curb Slope | 13.2 |

Remove & Replace Curb Ramp With Two New Directional Ramps or Equivalent.

R304.2.2, R304.5.3, STD 1115
