# Access Compliance Report Public Rights-of-Way (Curb Ramps)

Main Street: ESENCIA\_DR Cross Street: RISILLA\_ST Location: NW

ADA ID: RPRK211119131055 Ramp Type: Type 4 - Parallel Initial Pass/Fail: Fail Overall Compliance: No Severity Score: 15

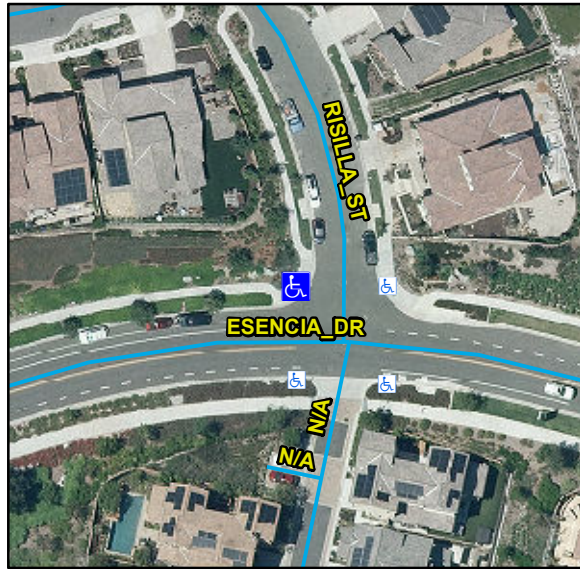
| Compliance | Description | Data | Compliance | Description | Data |
|---|---|---|---|---|---|
| Yes | Ramp Run Slope LT (%) | 7.8 | No | Ramp Run Slope RT (%) | 10.2 |

**Remove & Replace Curb Ramp With Two New Directional Ramps or Equivalent.**

**R304.3.2, STD 1115**
