# Access Compliance Report Public Rights-of-Way (Curb Ramps)

| Main Street: RISILLA_ST | | Cross Street: GALANTE_ST | | Location: | SW |
| ADA ID: RPRK211119131816 | Ramp Type: Type 4 - Parallel | Initial Pass/Fail: Fail | Overall Compliance: No | Severity Score: | 19 |

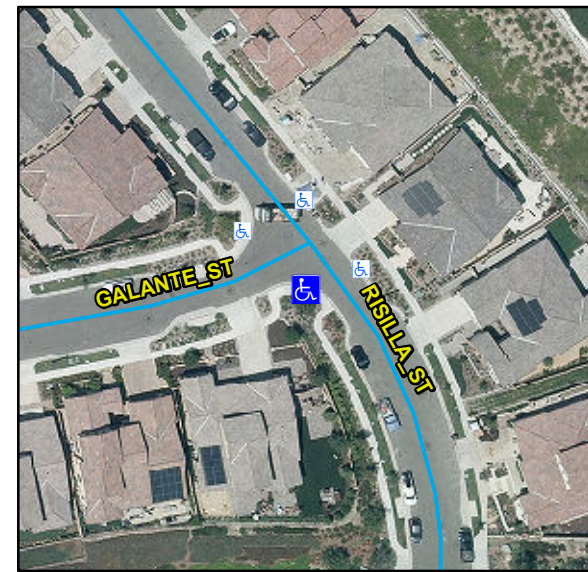
| Compliance | Description | Data | Compliance | Description | Data |
|---|---|---|---|---|---|
| No | Ramp Width LT (in) | 46 | No | Ramp Width RT (in) | 46 |
| Yes | Ramp Run Slope LT (%) | 3.1 | No | Ramp Run Slope RT (%) | 8.5 |

**Remove & Replace Curb Ramp With Two New Directional Ramps or Equivalent.**

**R304.5.1, R304.3.2, STD 1115**

Total Cost: \$ 4000

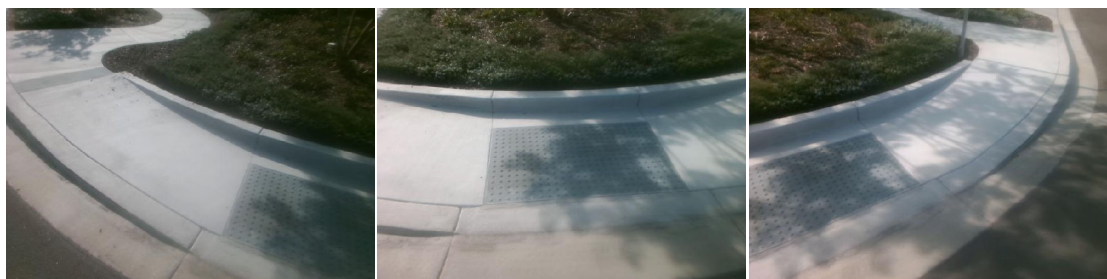
| Compliance | Description | Data | Compliance | Description | Data |
|---|---|---|---|---|---|
| N/A | Ramp Length LT (in) | 105 | N/A | Ramp Length RT (in) | 108 |
| Yes | Ramp Cross Slope LT (%) | 1.5 | Yes | Ramp Cross Slope RT (%) | 0.1 |
